## **STREETS, BUILDINGS & UTILITIES COMMITTEE**

**May 2, 2023**

Re: Condition Assessment – Detached Garage/Barn  
Property Having the Physical Address of 111 S High Street, Markesan, WI 53946  
Tax Parcel ID Number: 251-00500-0000

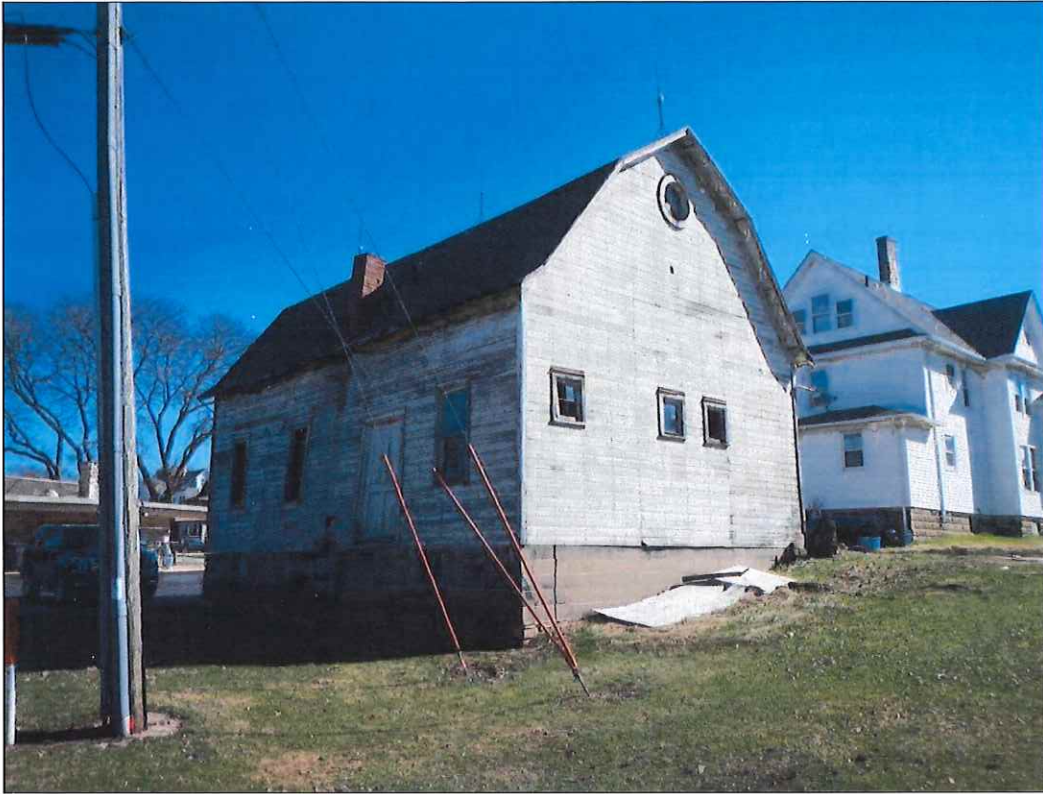
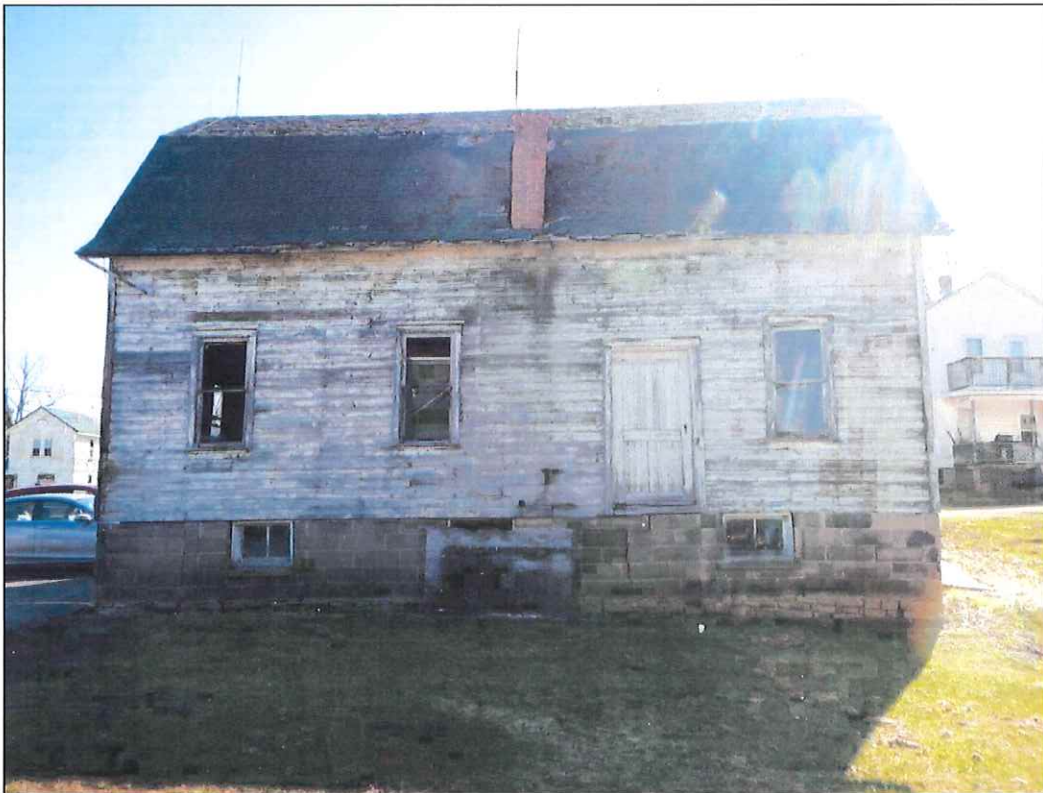
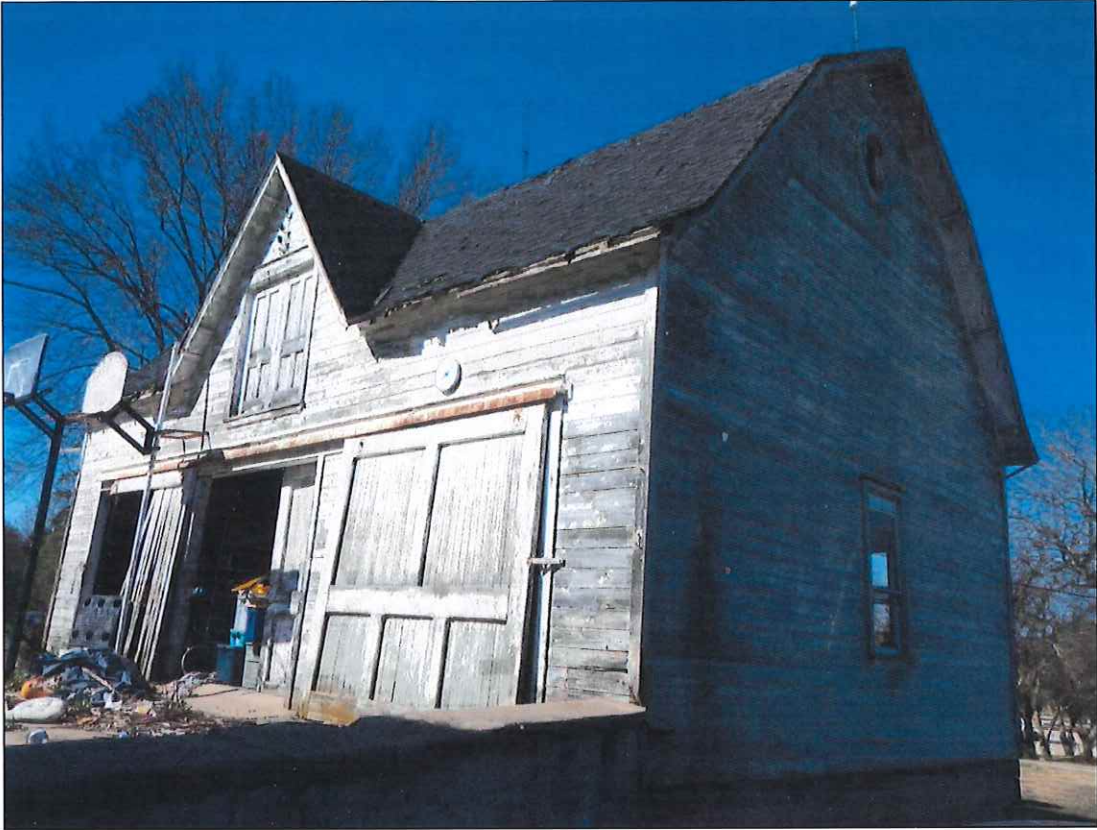
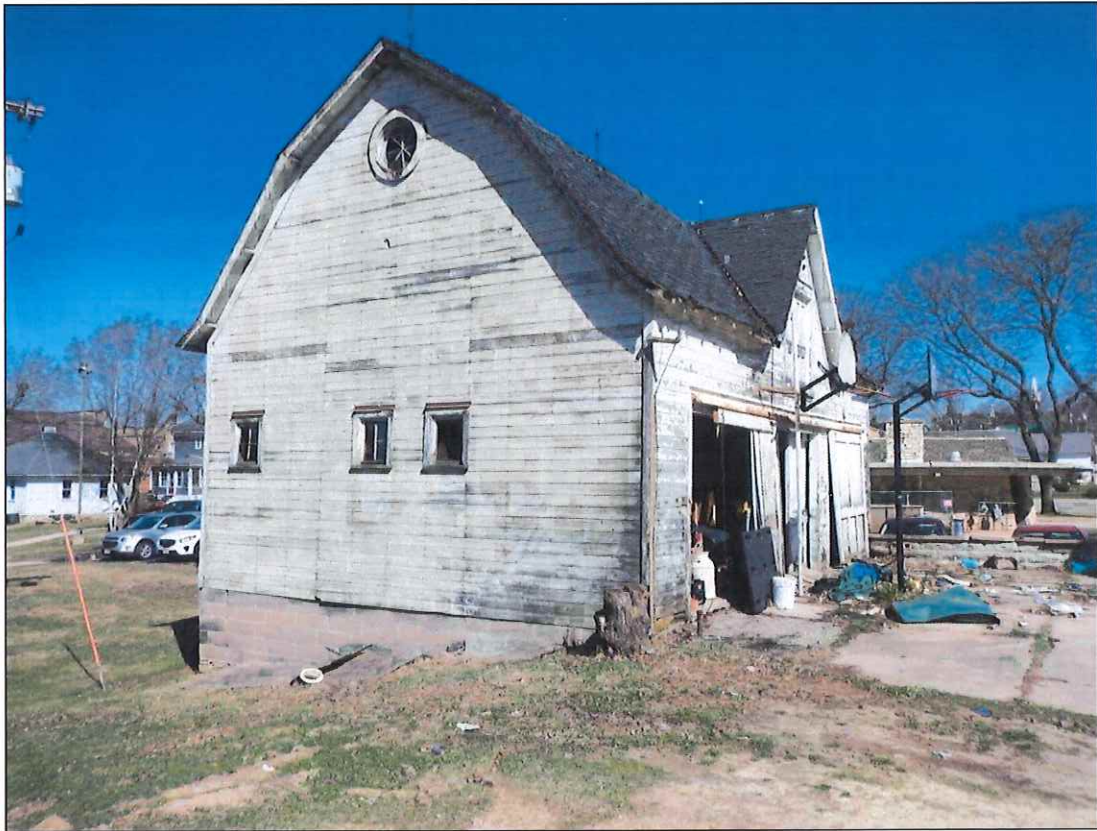
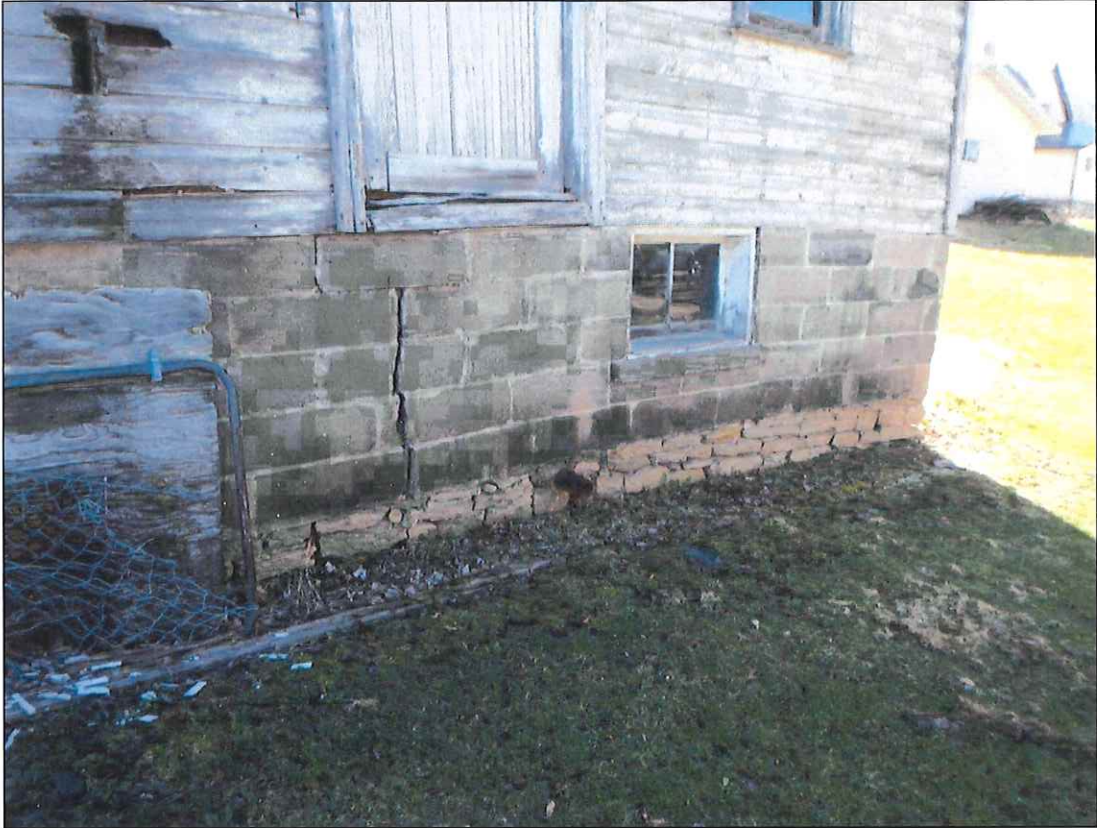
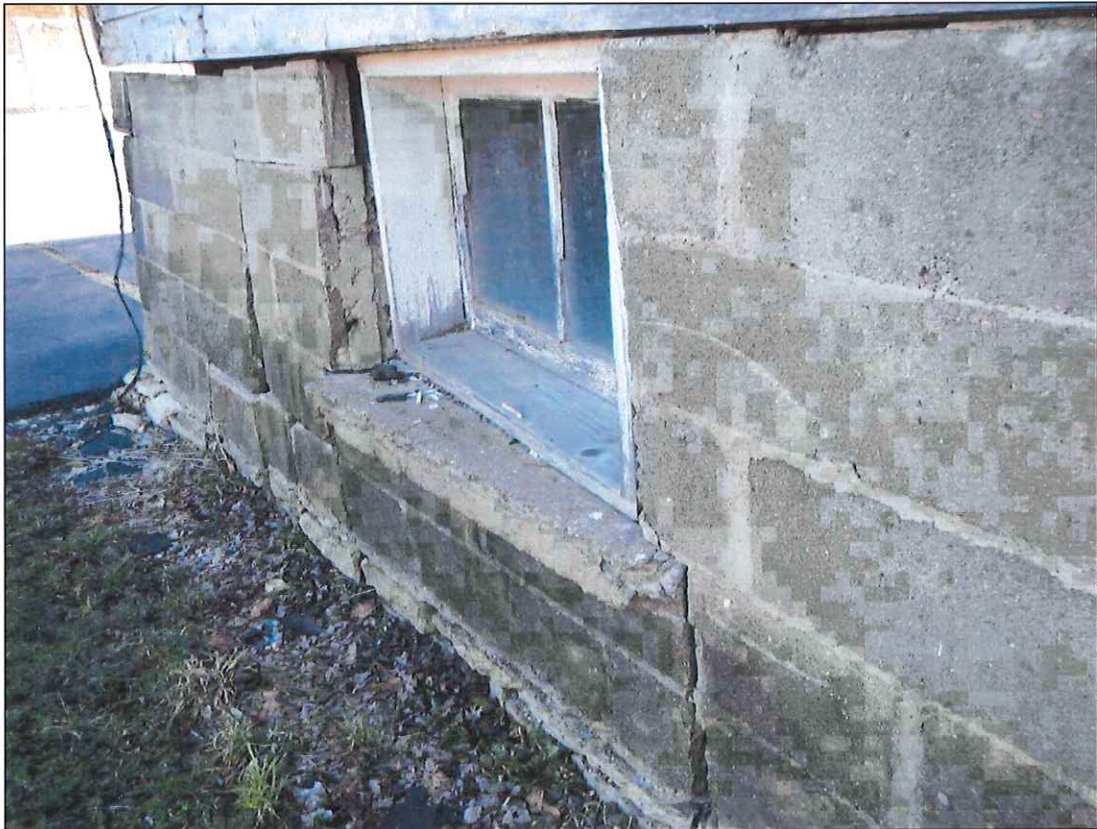
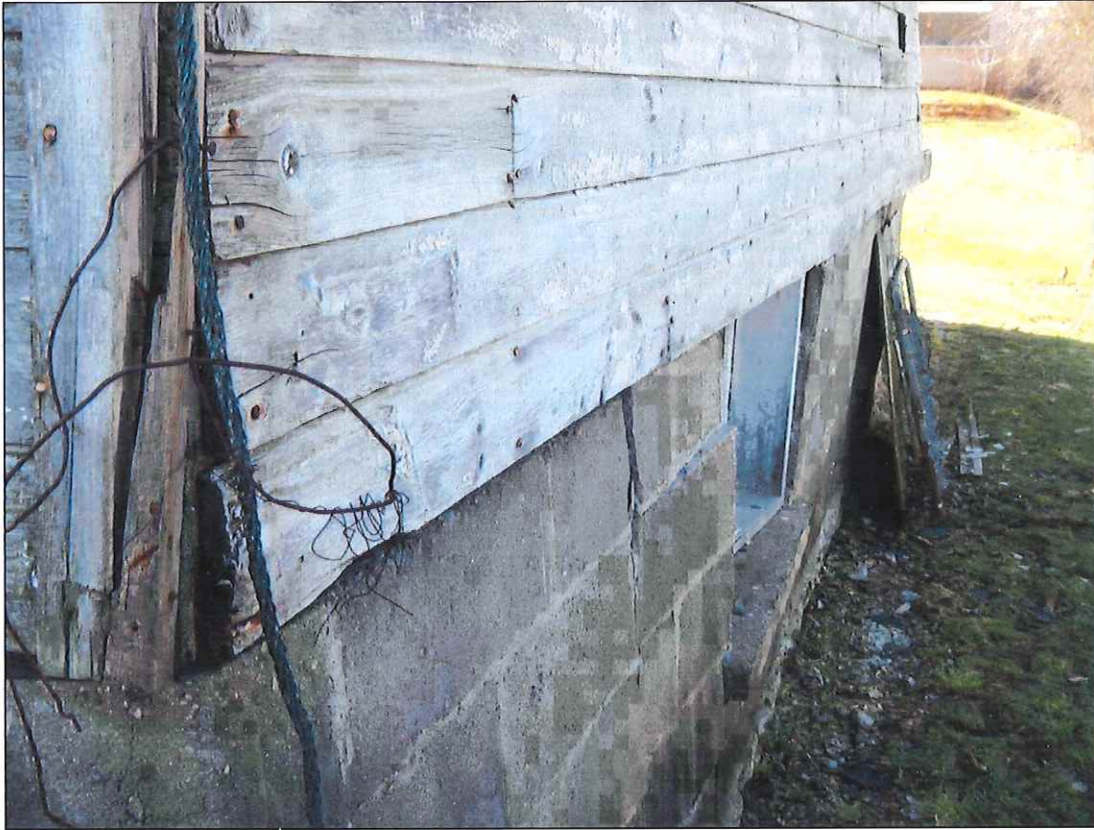
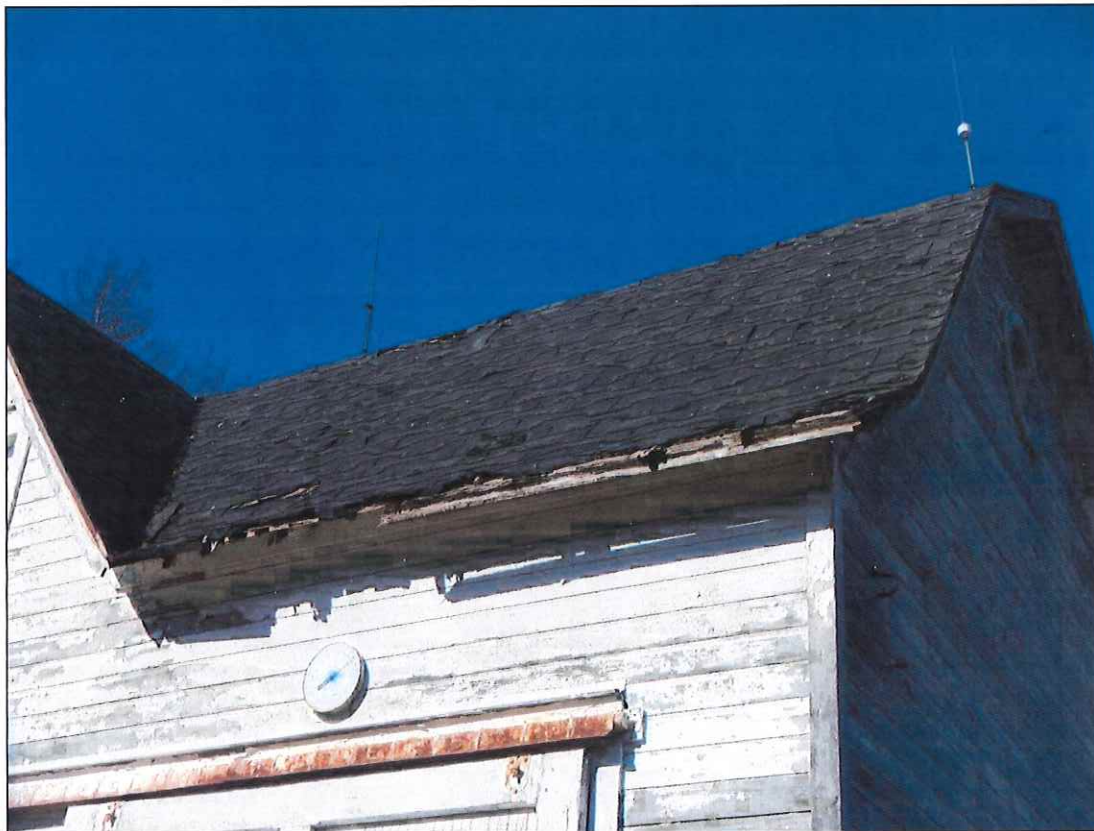
### PHOTOGRAPH APPENDIX

- 2.1.1 The structure was observed to have been left open with doors unsecured and non-functioning. Various items were observed to be stored in a garage. There is also an unsecured window opening on the west side of the building's foundation which provides relatively easy access to the building's crawl space. The open garage and its contents are likely to attract children and/or other persons who may be unable to appreciate the potential risks posed. In my professional opinion, the garage is an "attractive nuisance". As such I recommend immediate measures be taken to secure the garage.

- 2.1.2 The structures exterior painted wooden surfaces were all observed to be in Poor condition overall and suffering from a prolonged period of deferred maintenance resulting in chipped, cracked and deteriorated (rotted) components. Painted surfaces include but may not be limited to: soffit and fascia boards, siding, window and window opening components, miscellaneous trim and doors.

- 2.1.3 The roof is clad in asphalt-based shingles which were observed to be chipped, cracked, and curled with portions of the shingles missing. The shingles were observed to be in Poor overall condition and in need of immediate replacement. Additionally, based on the condition of the shingles, it is highly likely that the roof is actively leaking, and sections of the roof deck shall require replacement.

- 2.1.4 Multiple windows were observed to be broken and/or missing thereby providing little if any weatherization benefits. Additionally, the remaining windows, being of wooden-frame construction, were found heavily deteriorated and in need of replacement.

- 2.1.7 The structure's masonry foundation is composed of primarily stone and concrete block. The foundation was observed to have significant structural deficiencies. The deficiencies are particularly noticeable on the west side and the NW and SW corners of the building and include large vertical cracks, substantial longitudinal bowing, separation from the building's wooden frame and mortar deterioration. Generally, the foundation is in overall Poor condition and requires extensive repairs and/or replacement in the immediate future.

- 2.1.8 The shifting of the foundation was observed to have negatively impacted the wooden frame of the building and has pulled the bottom plate of the building out, resulting in a structure that is not only out of plumb, but one that has diminished the building's overall stability.

- 2.1.9 The garage was observed to be in overall Poor structural condition. In my professional opinion, without extensive repairs, the building's condition will continue to degrade until such a time as it will collapse completely or at least in part.
- 2.1.10 Additionally, due to the cracked and peeling paint, deteriorated siding, missing doors, structural deficiencies and the structure's general unkempt appearance, the building is, in my professional opinion, in overall Poor condition Aesthetically speaking.
